HATCH COVERS INSPECTION REPORT OF DRY BULK VESSELS

Vessel's Name	: M/V TBN
IMO No	: 100001
Place of Inspection	: Freeport, Bahamas
Date of Inspection	:25, Mar. – 28, Apr. 2009
Inspector's Name	:Bournias Th.

Section 3: Hatch Covers / Coamings Inspection Form

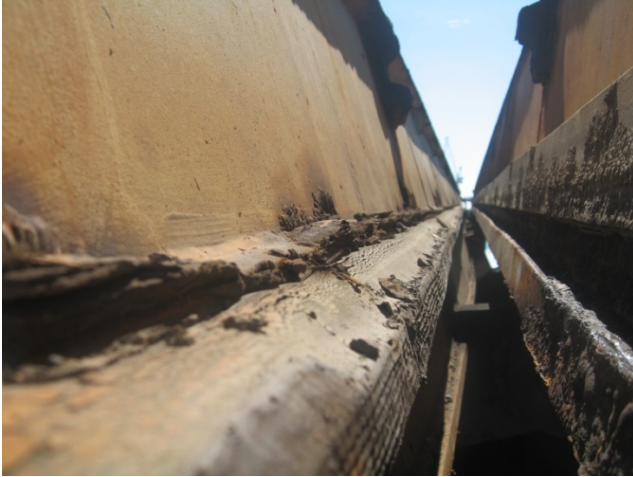
Cross joint as found

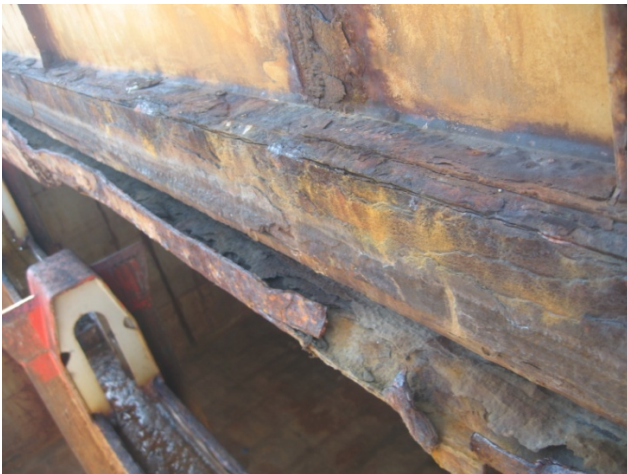
**Compression flat and drain channel
In poor condition as found**

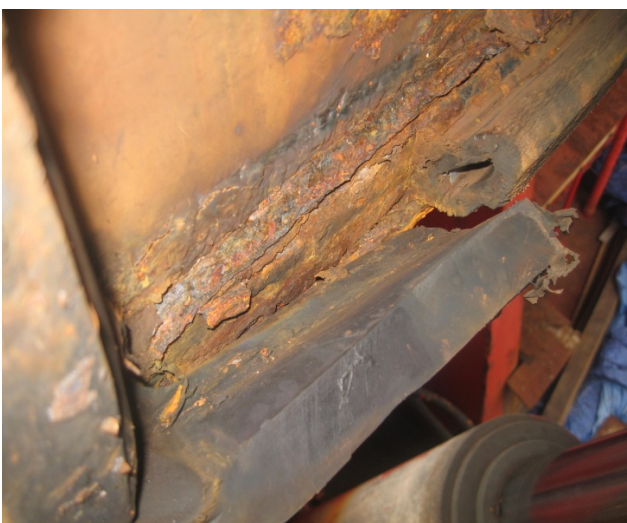
Broken rubber packing as Found

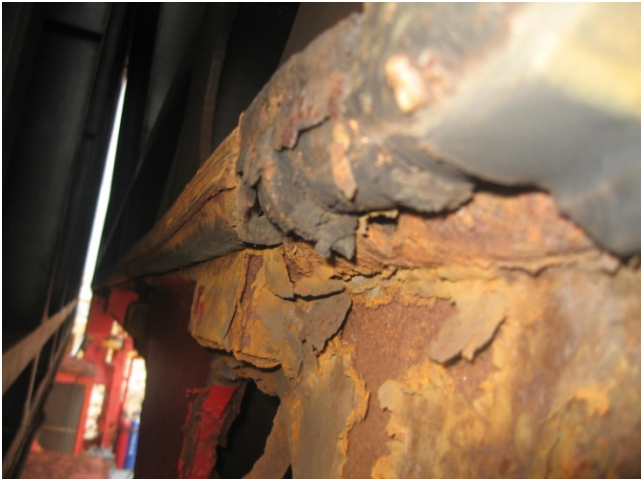
**Internal view of packing in
Poor condition as found.**

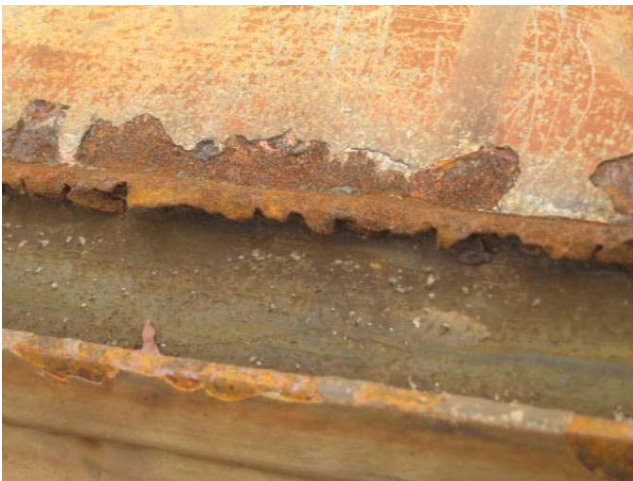
**Cross joint rubber channel as found
Is totally wasted.**

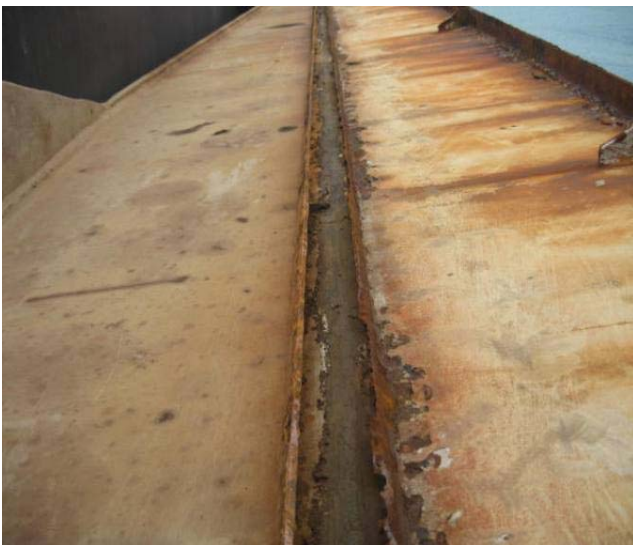
**General view of channel as found
Totally wasted.**

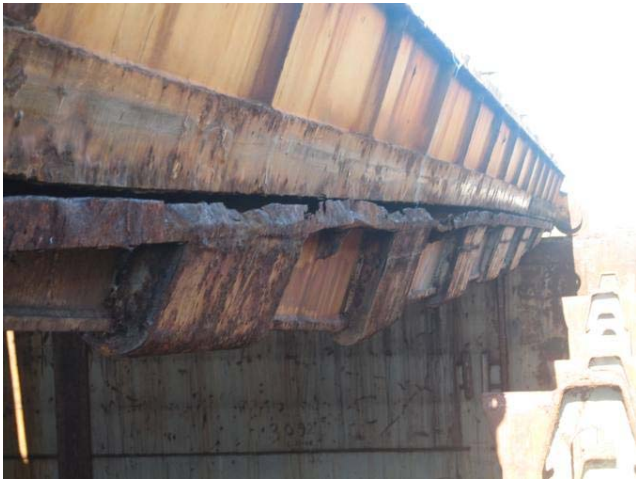
**Flat compression of cross joint
With totally wasted drain channel.**

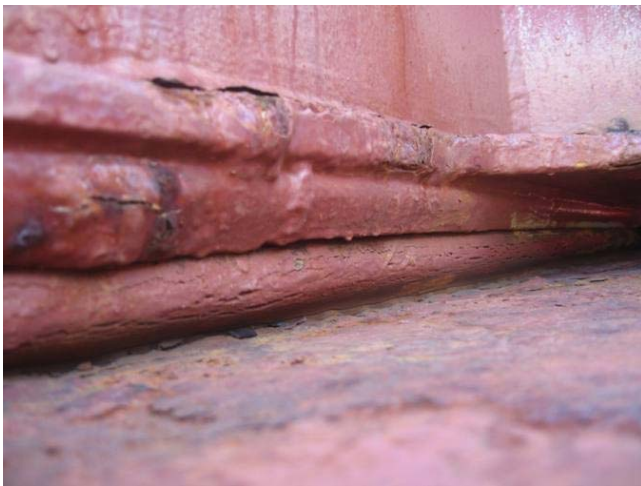
**Wasted and frozen over-compressed
Rubber packing**

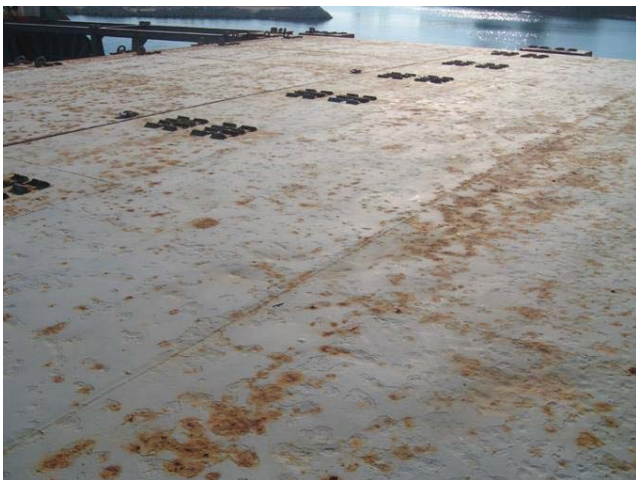
Top plating view with pitting areas.

**Should be taken under consideration
For next docking repairs**

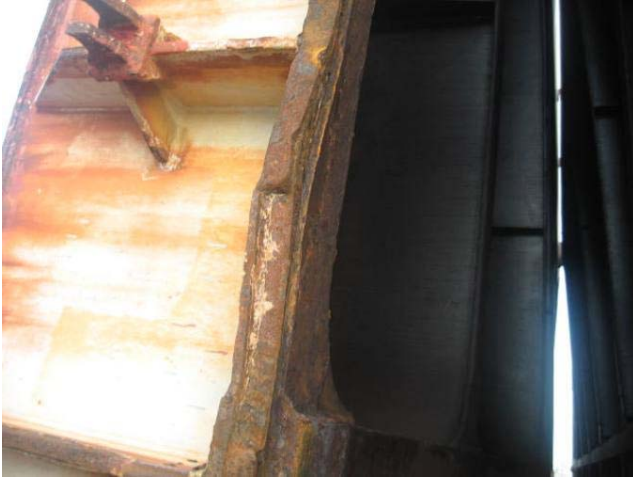
**Flat compression area uneven
And wasted**

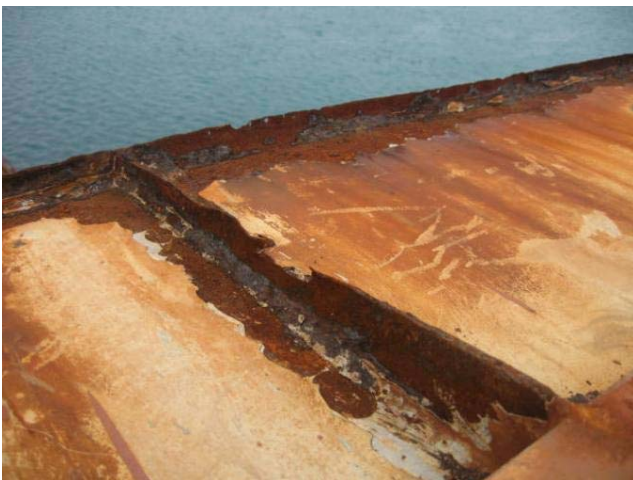
**Bracket of cover side totally wasted.
Several brackets of sides replaced.**

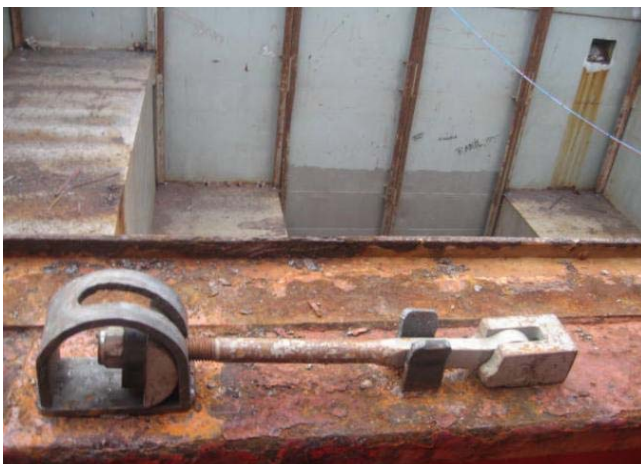
**Reconditioned cleat.
See fabricated crutch same
Fabrication for 12 pcs installed
And adjusted in correct position.**

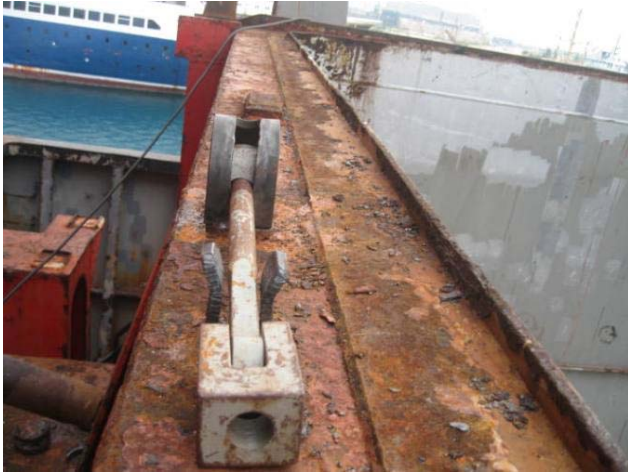
**Reconditioned cleat with
Fabricated onboard crutch**

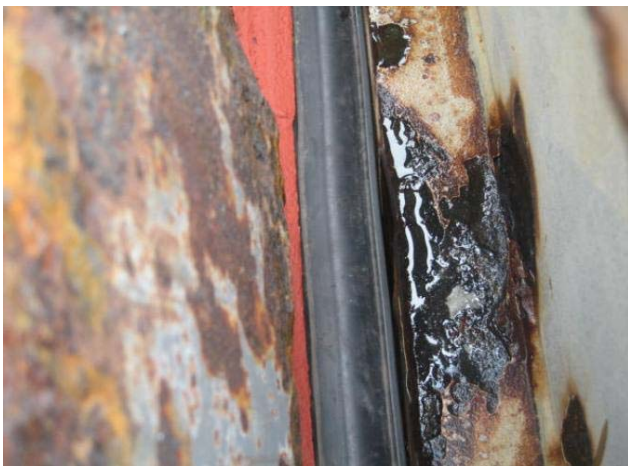
**Cross joint as found with big gap
Between packing and flat
Compression.**

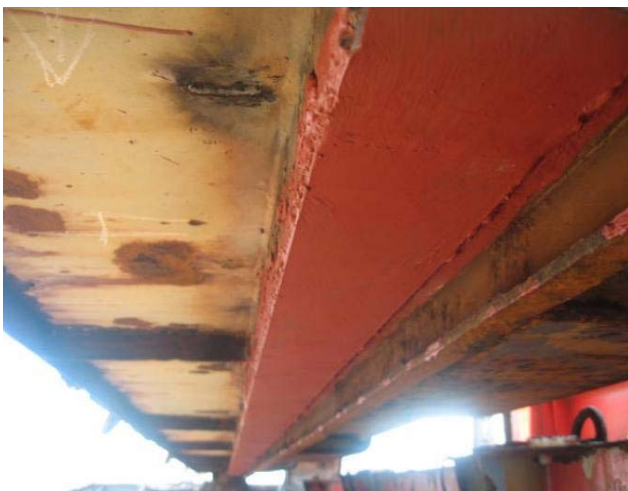
**Flat compression as placed and
Adjusted.**

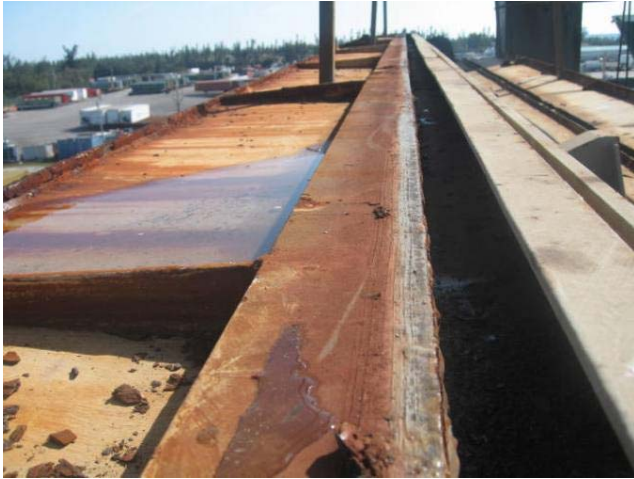
**Print mark of rubber packing on
The edge of flat compression.**

**Looks that actual compression
Is just on the limit.**

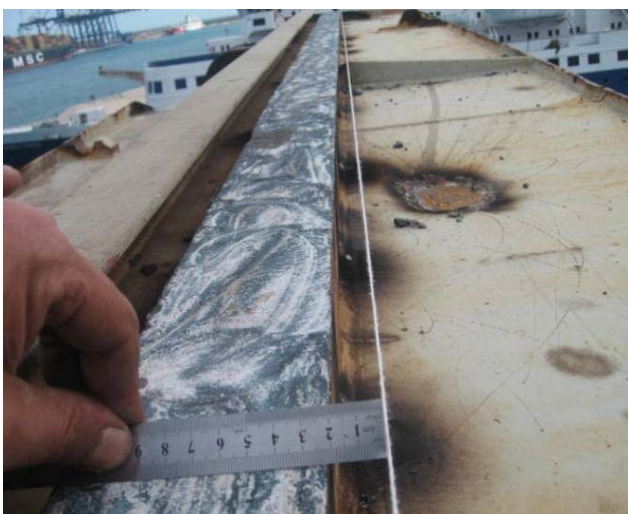
**After inspection it is obvious that flat
Cross joint compression is
Misaligned and about 20mm
Of deflection.**

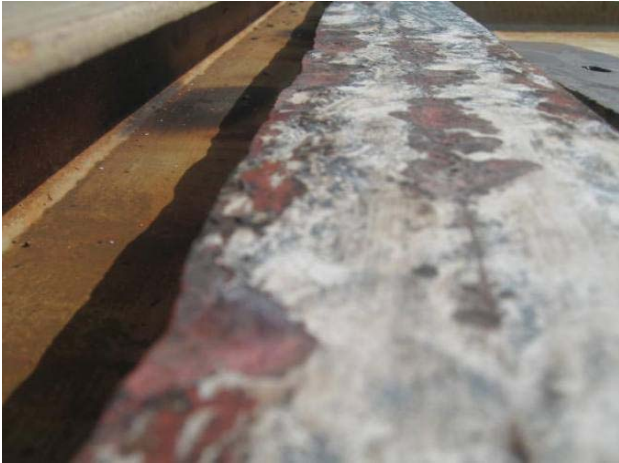
Flat compression
At another cover with deep pitting
And uneven. In this respect consider
Same as a general defect.

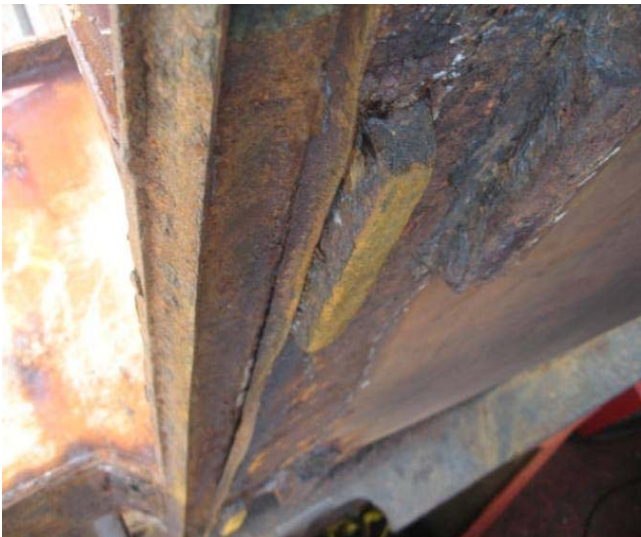
**Wasted part of internal area
Guide and resting wastage.**

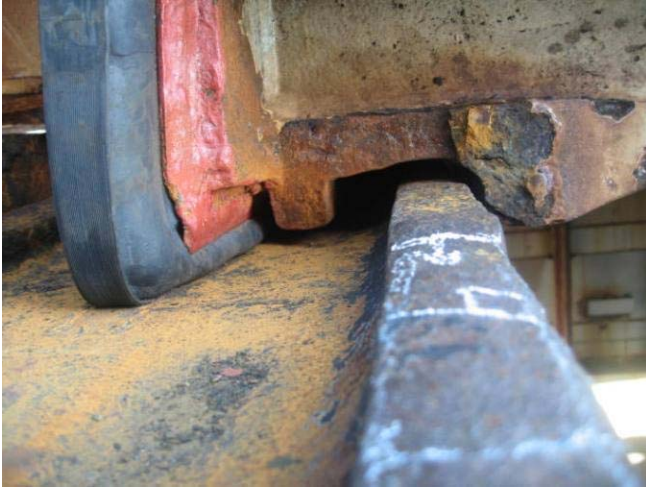
At resting point of cover it is obvious that there is no steel to steel contact with resting pad and enhanced hatch rim. (side area) This is caused from wastage as described above, further is causing also over compression of packing and eventually packing distortion.

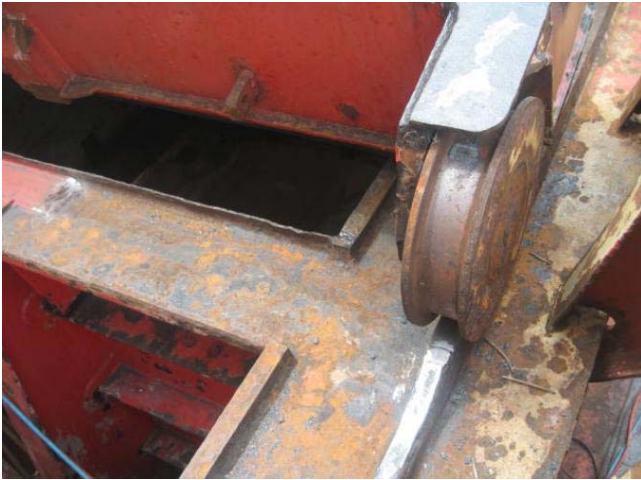
At cover No 4 panel 1 observed Problems at operation during Open/closing. Same repaired

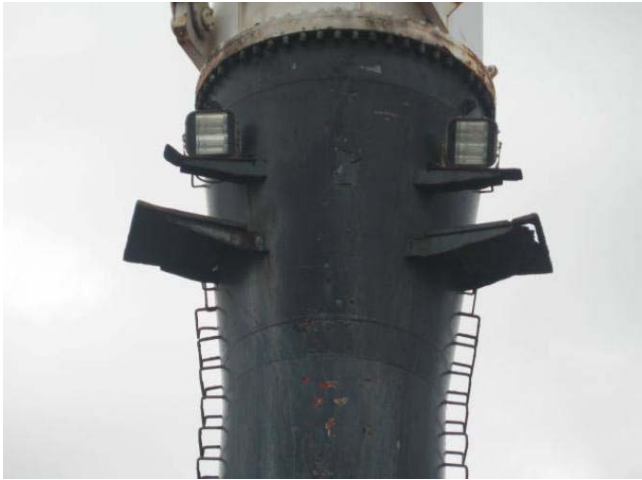
Destroyed platforms of crane no2.

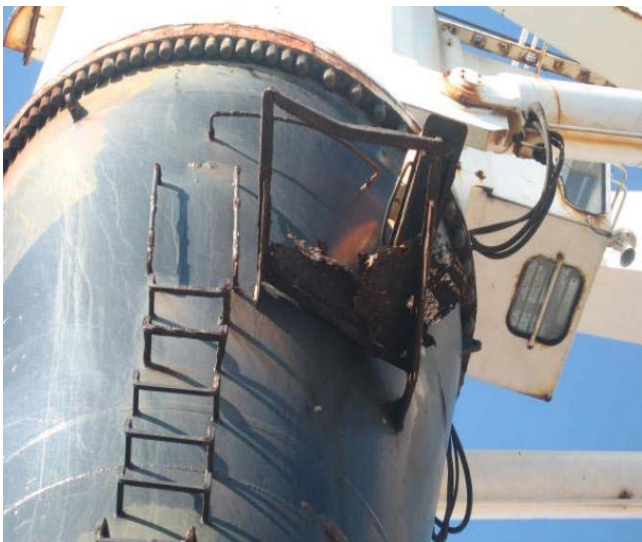
Crane No1 with destroyed platforms
