HATCH COVERS INSPECTION REPORT OF DRY BULK VESSELS

Vessel's Name	: M/V TBN
IMO No	: 100001
Place of Inspection	: Freeport, Bahamas
Date of Inspection	:25, Mar. – 28, Apr. 2009
Inspector's Name	:Bournias Th.

Section 3: Hatch Covers / Coamings Inspection Form

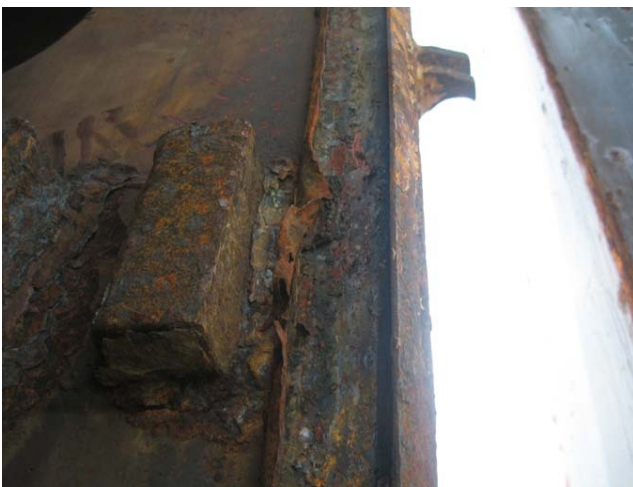
**Side rubber channel area.
Typical wastage as found.**

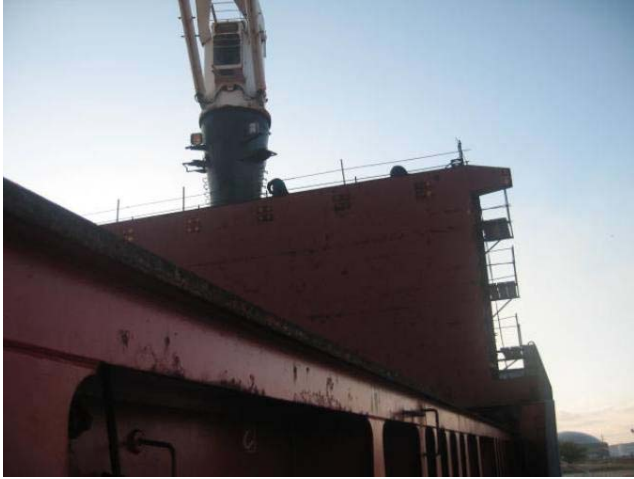
**Tower staging at Covers with
Safety railing on top of covers**

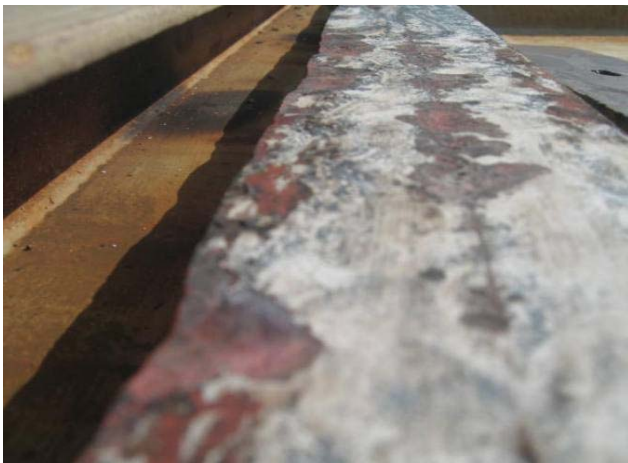
**Flat compression with deep pits.
Same is causing miss compression**

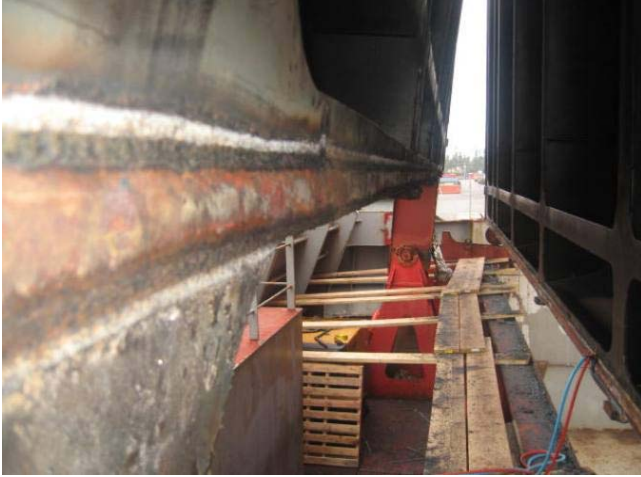
Rubber channel at aft part removed

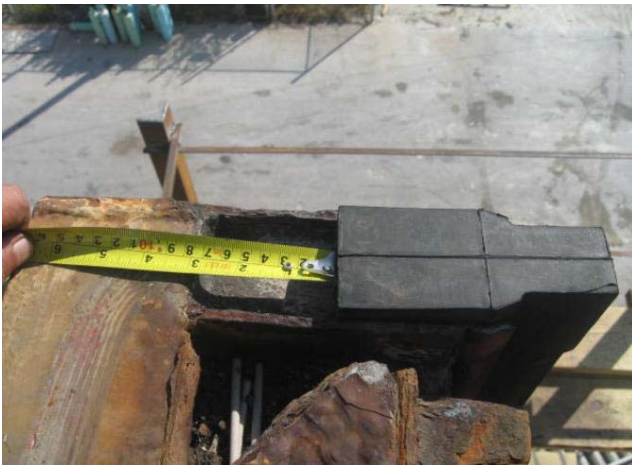
**End corner piece mistaken spare
Part.**

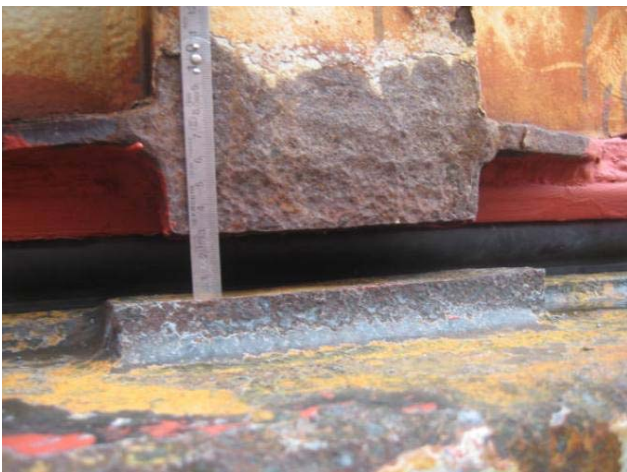
**Closing position of covers shows
Approx. 30mm of over compression
Since aft bearing pad is not touching
Bearing plate on coaming.
So that it is obvious that further
Adjustment is requirement.**

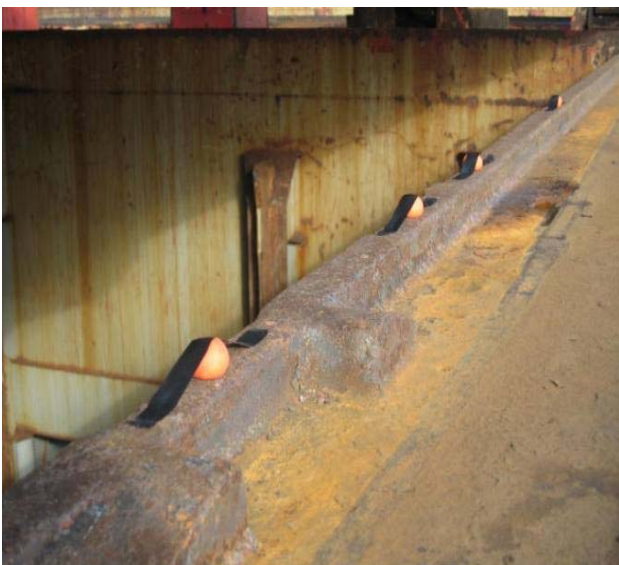
**Means of compression checking
Since side bearing pads are internal
And cannot be seen but from hold
Side.**

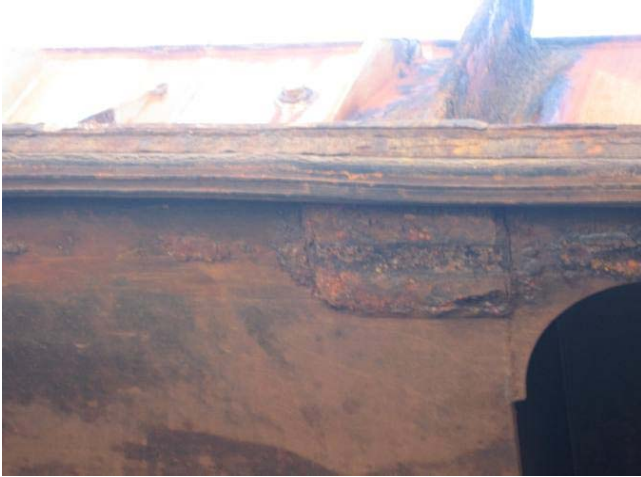
**Bearing pad (resting pad) of cover
Internally as above described.**

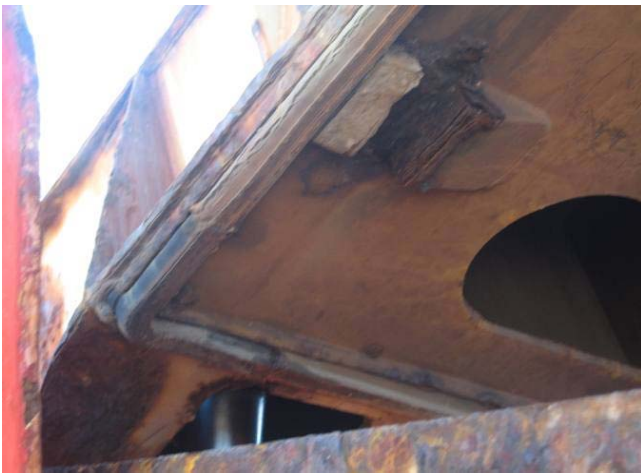
**Guide with bearing pad internal
Of covers.**

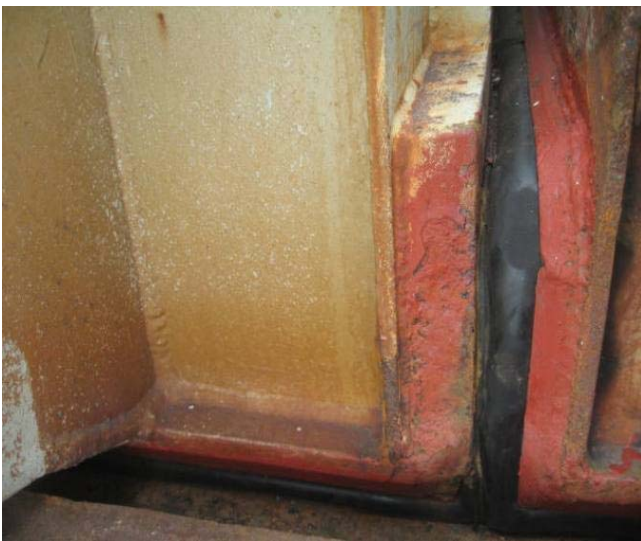
Cross joint view in closed position.

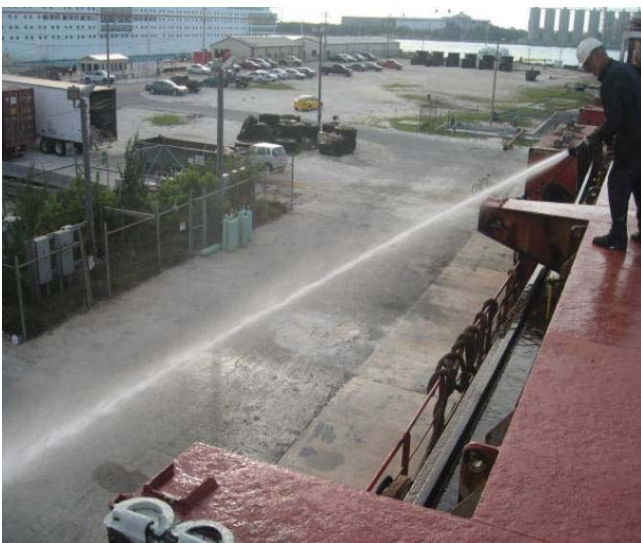
Pressure testing of fire hose Prior commencing hose test.

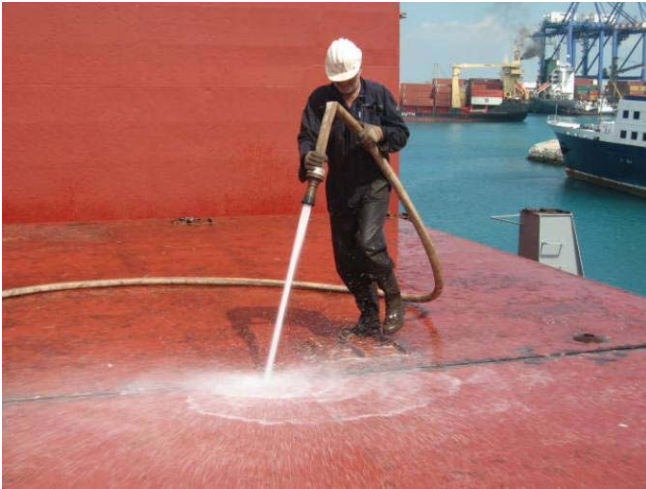
Hose test of covers
